THE CHAMPLAIN TOWERS COLLAPSE

Professional & Legal Implications for Design Firms

February 22 at 2 PM ET

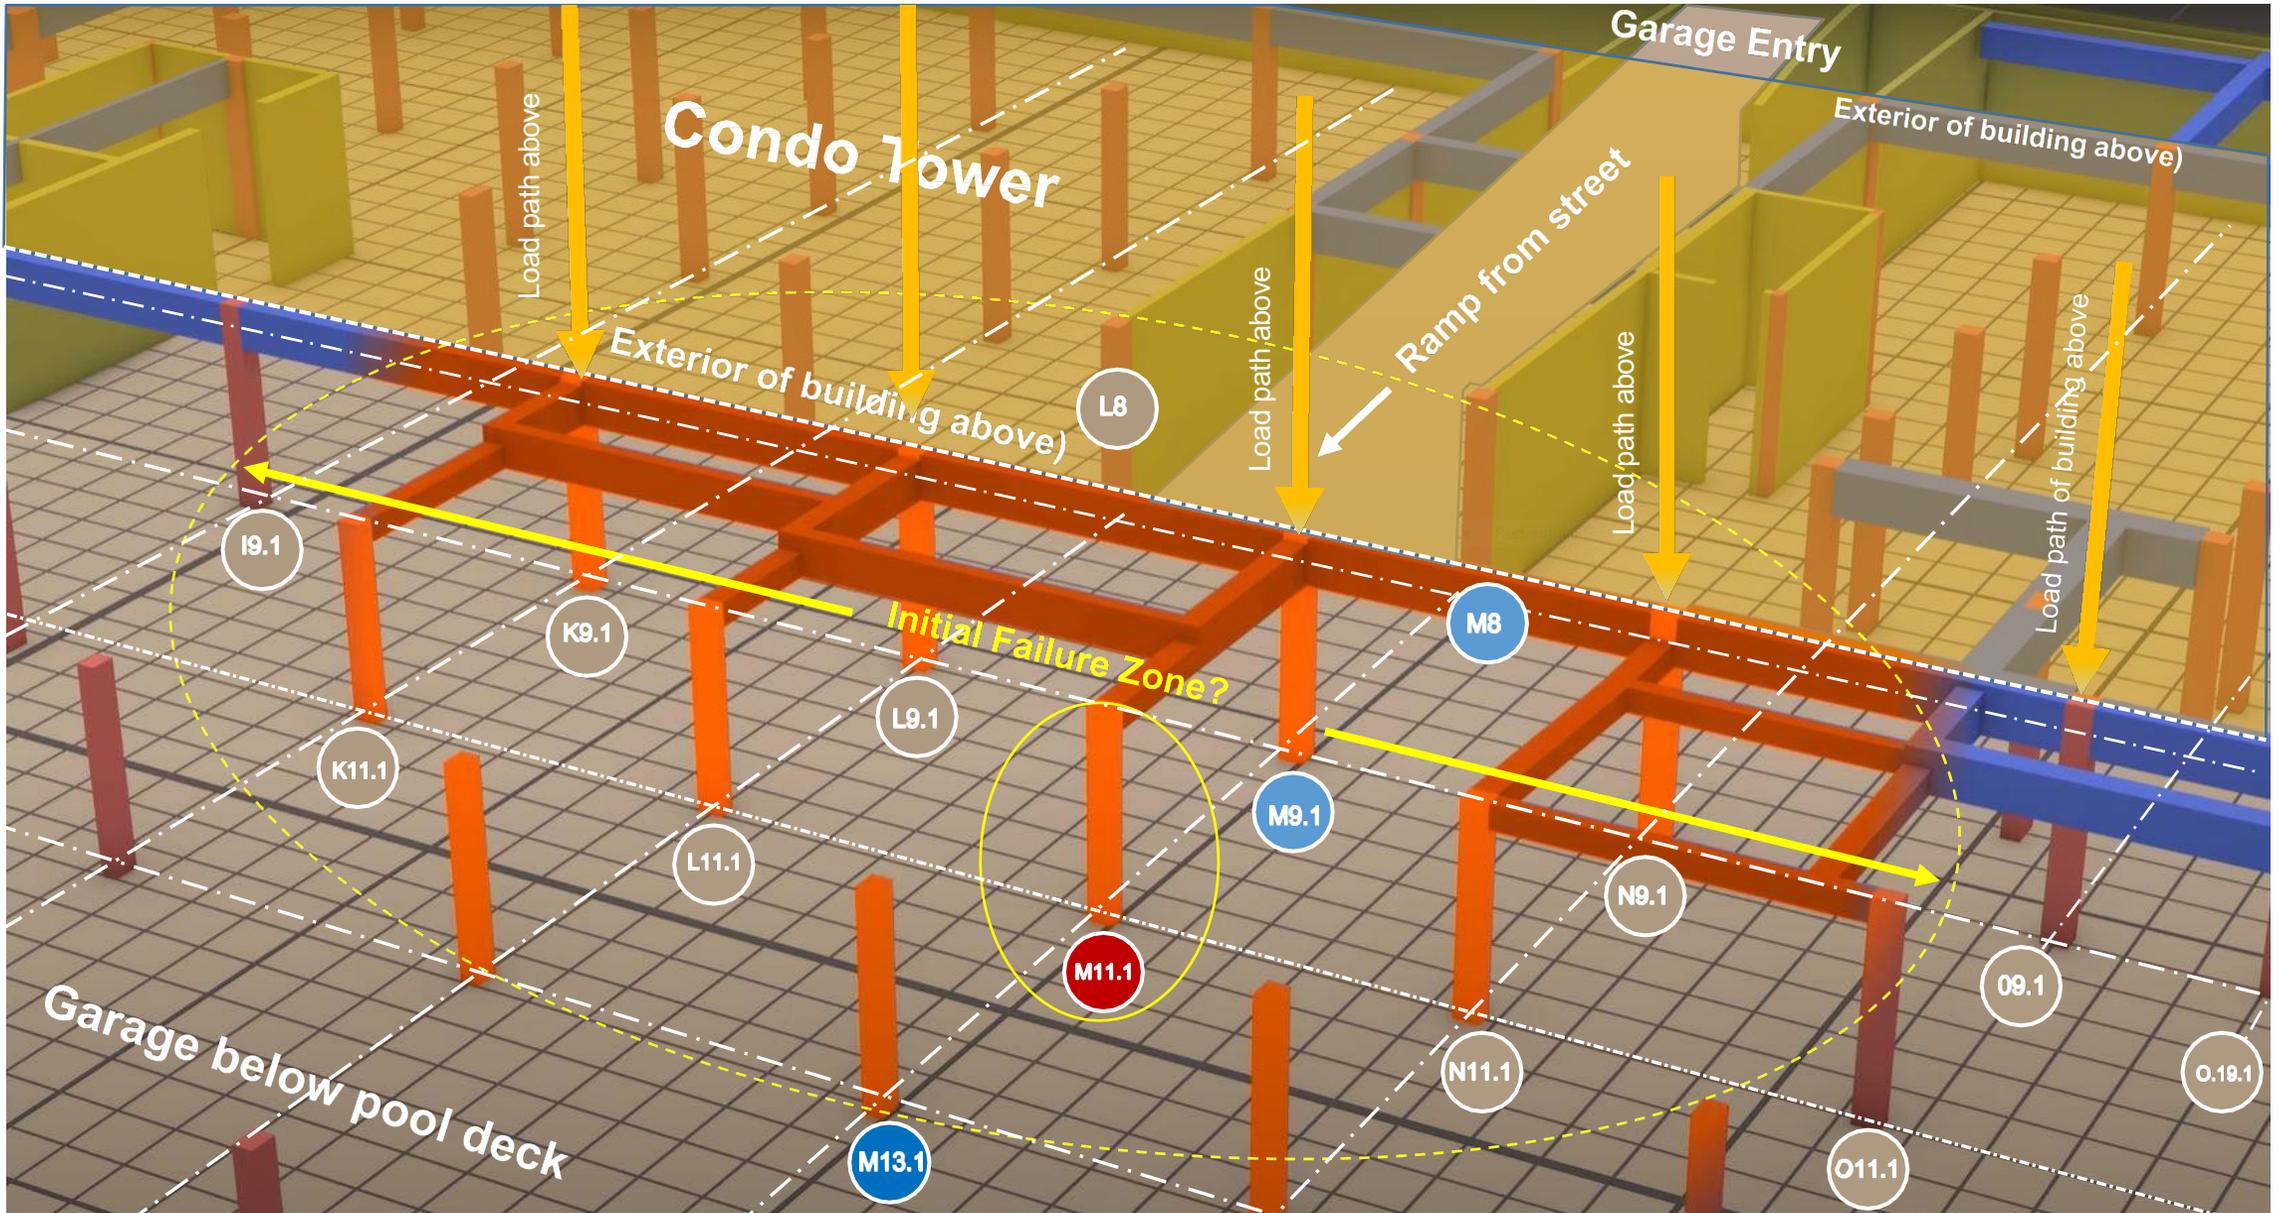
View of Parking Garage situated below Pool Deck. Parking Garage/Pool Deck and Building Tower Structure are connected (No EJ)

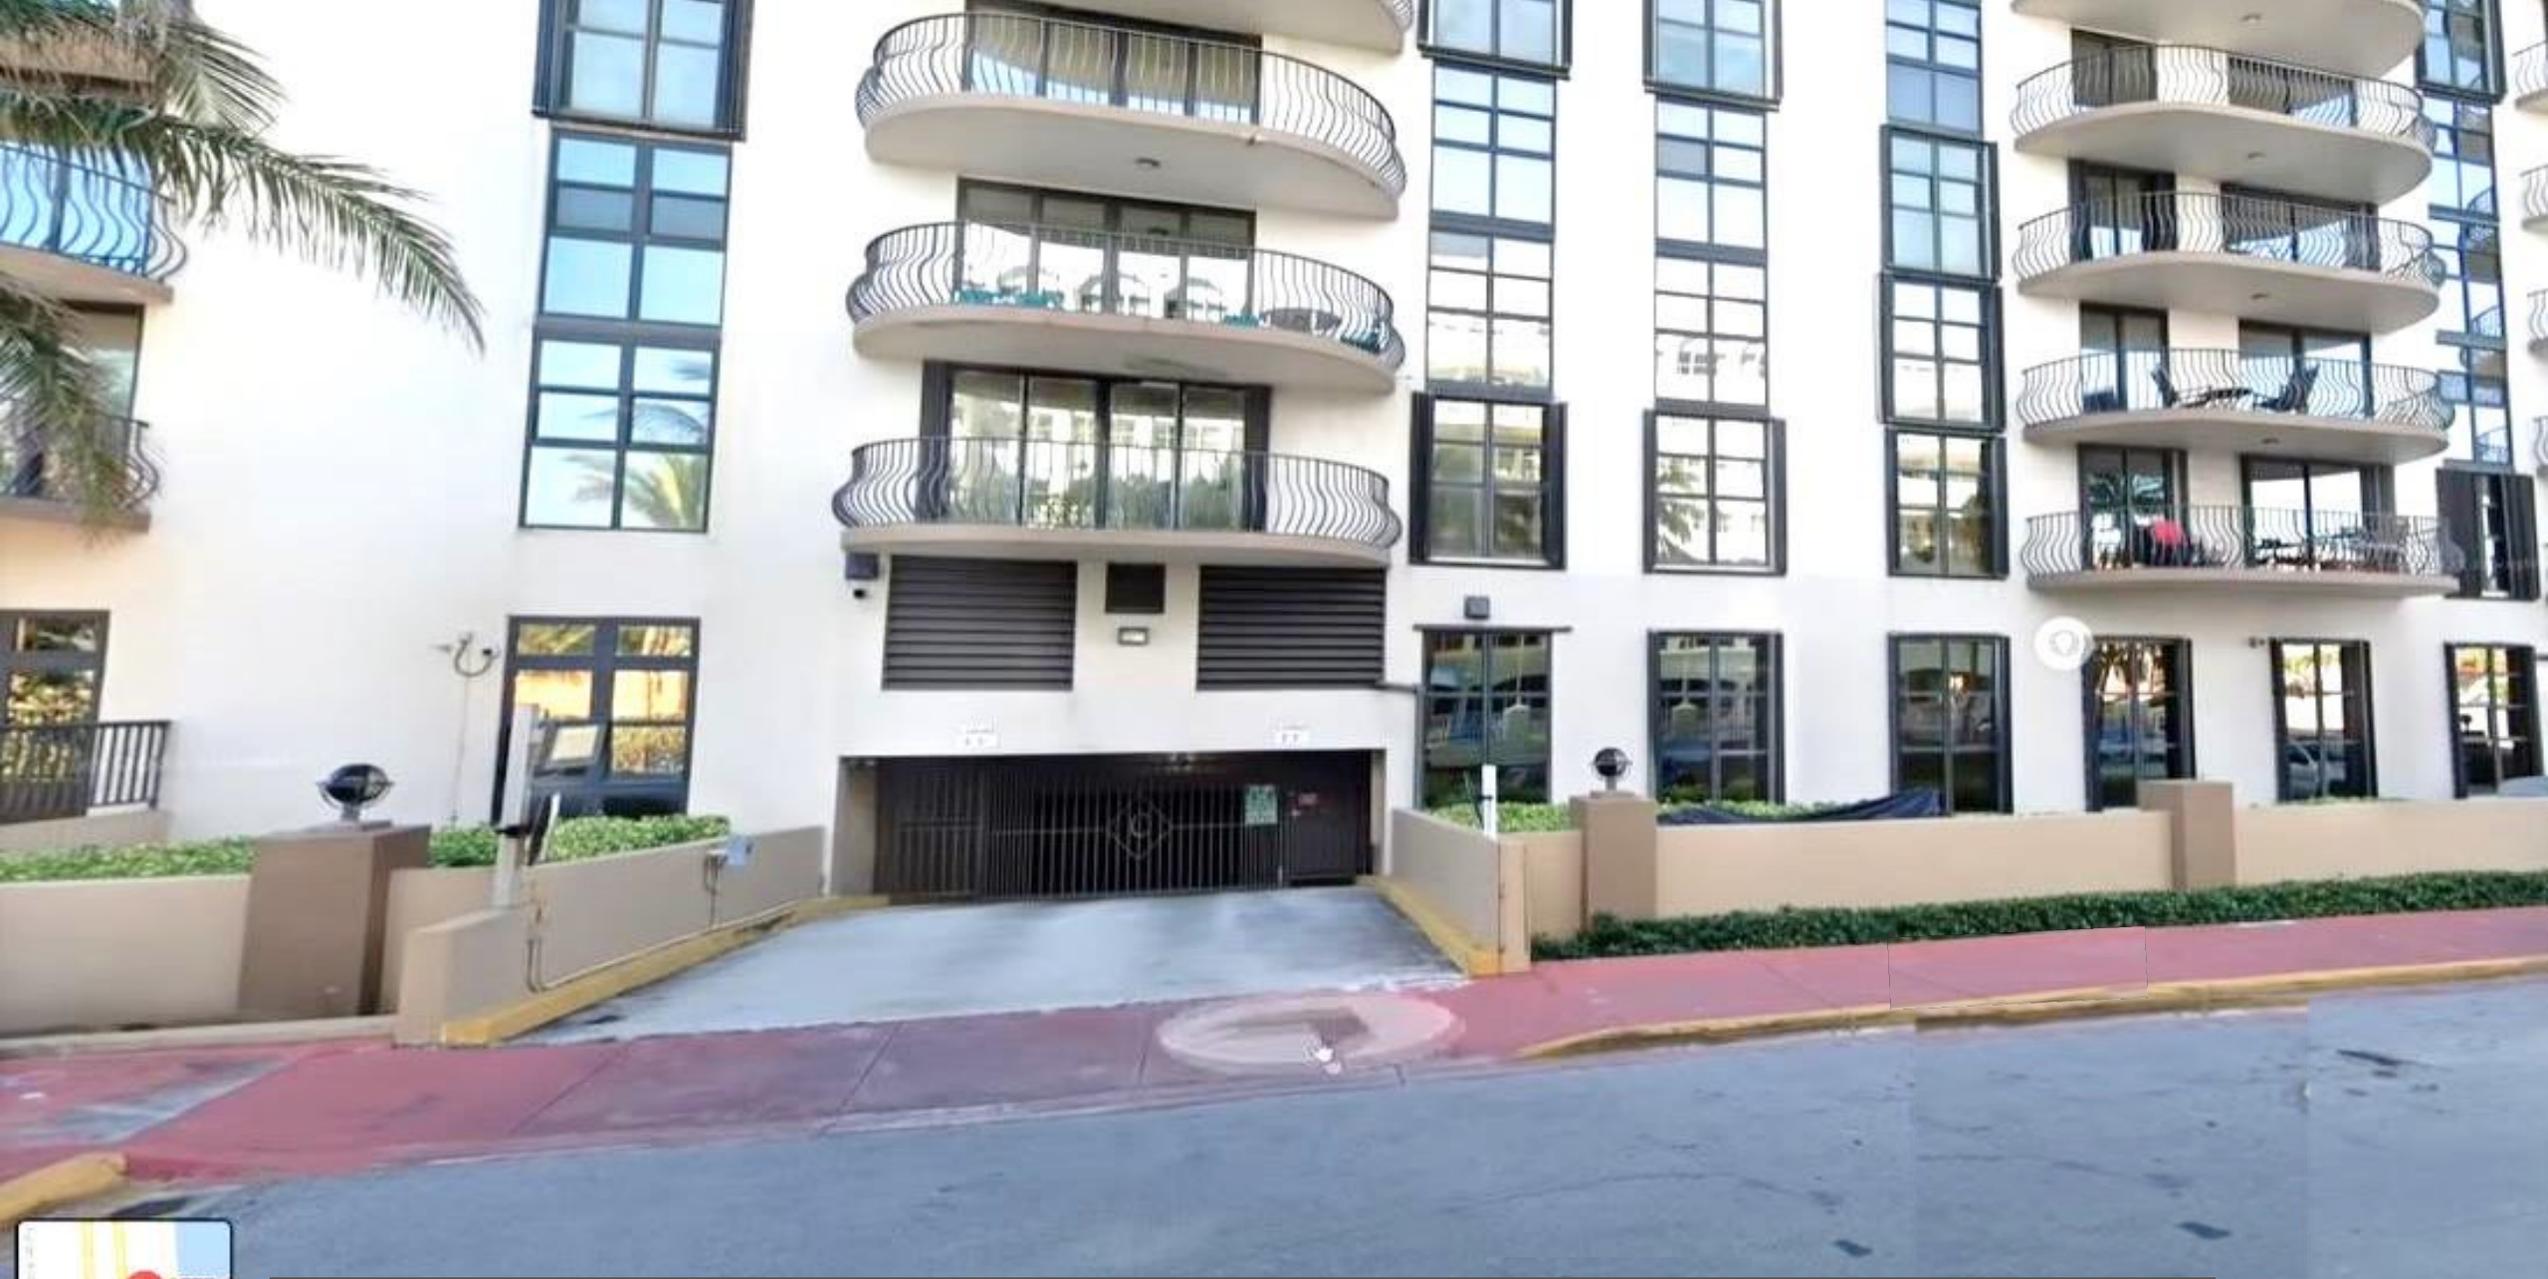
Tourist films into garage door opening 7 minutes prior to building collapse after hearing very loud noises from garage entry.

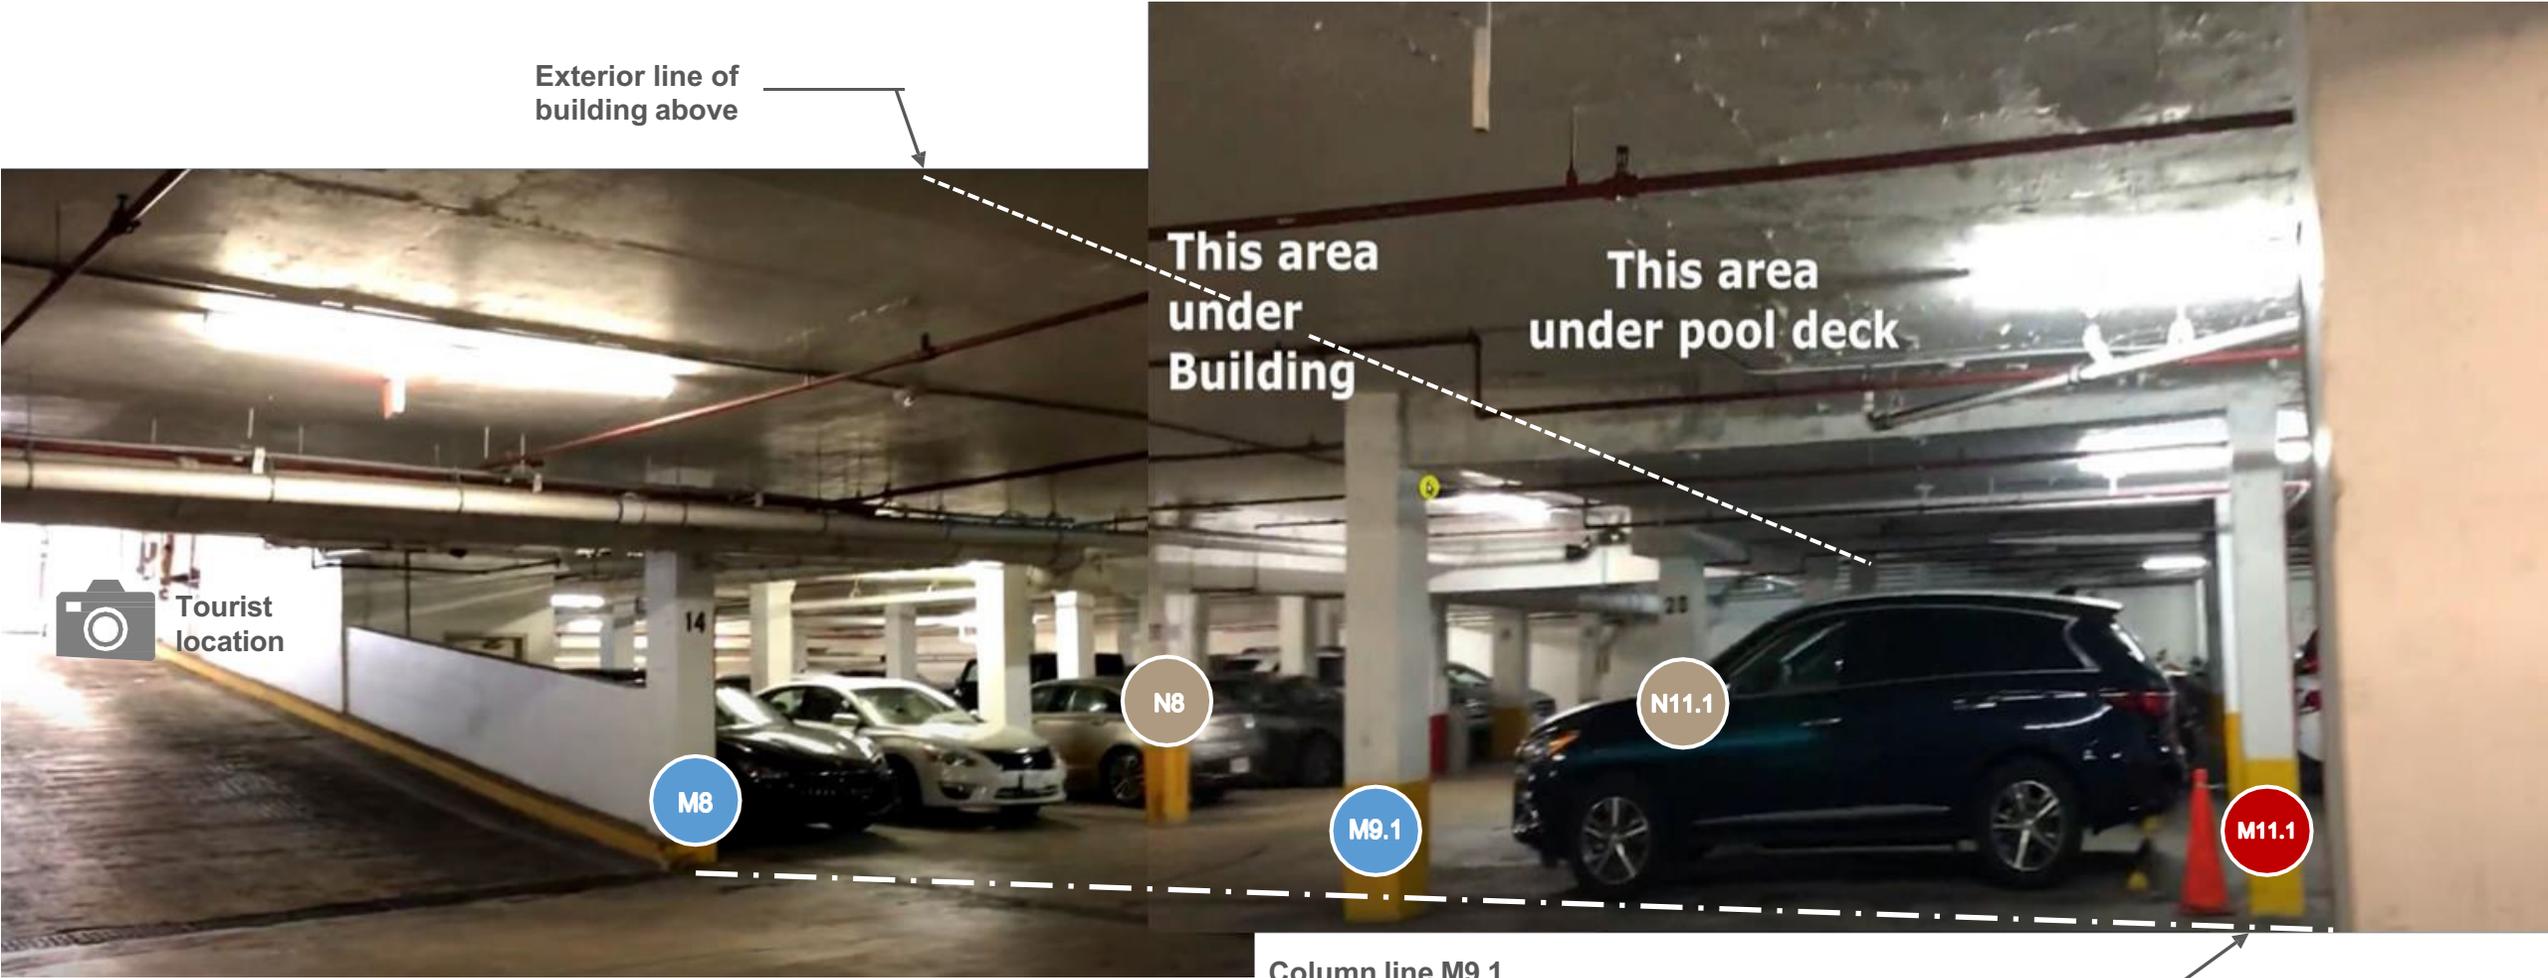
Column line M9.1 supports building façade above.

Tourist film showing column M11.1 collapsed?

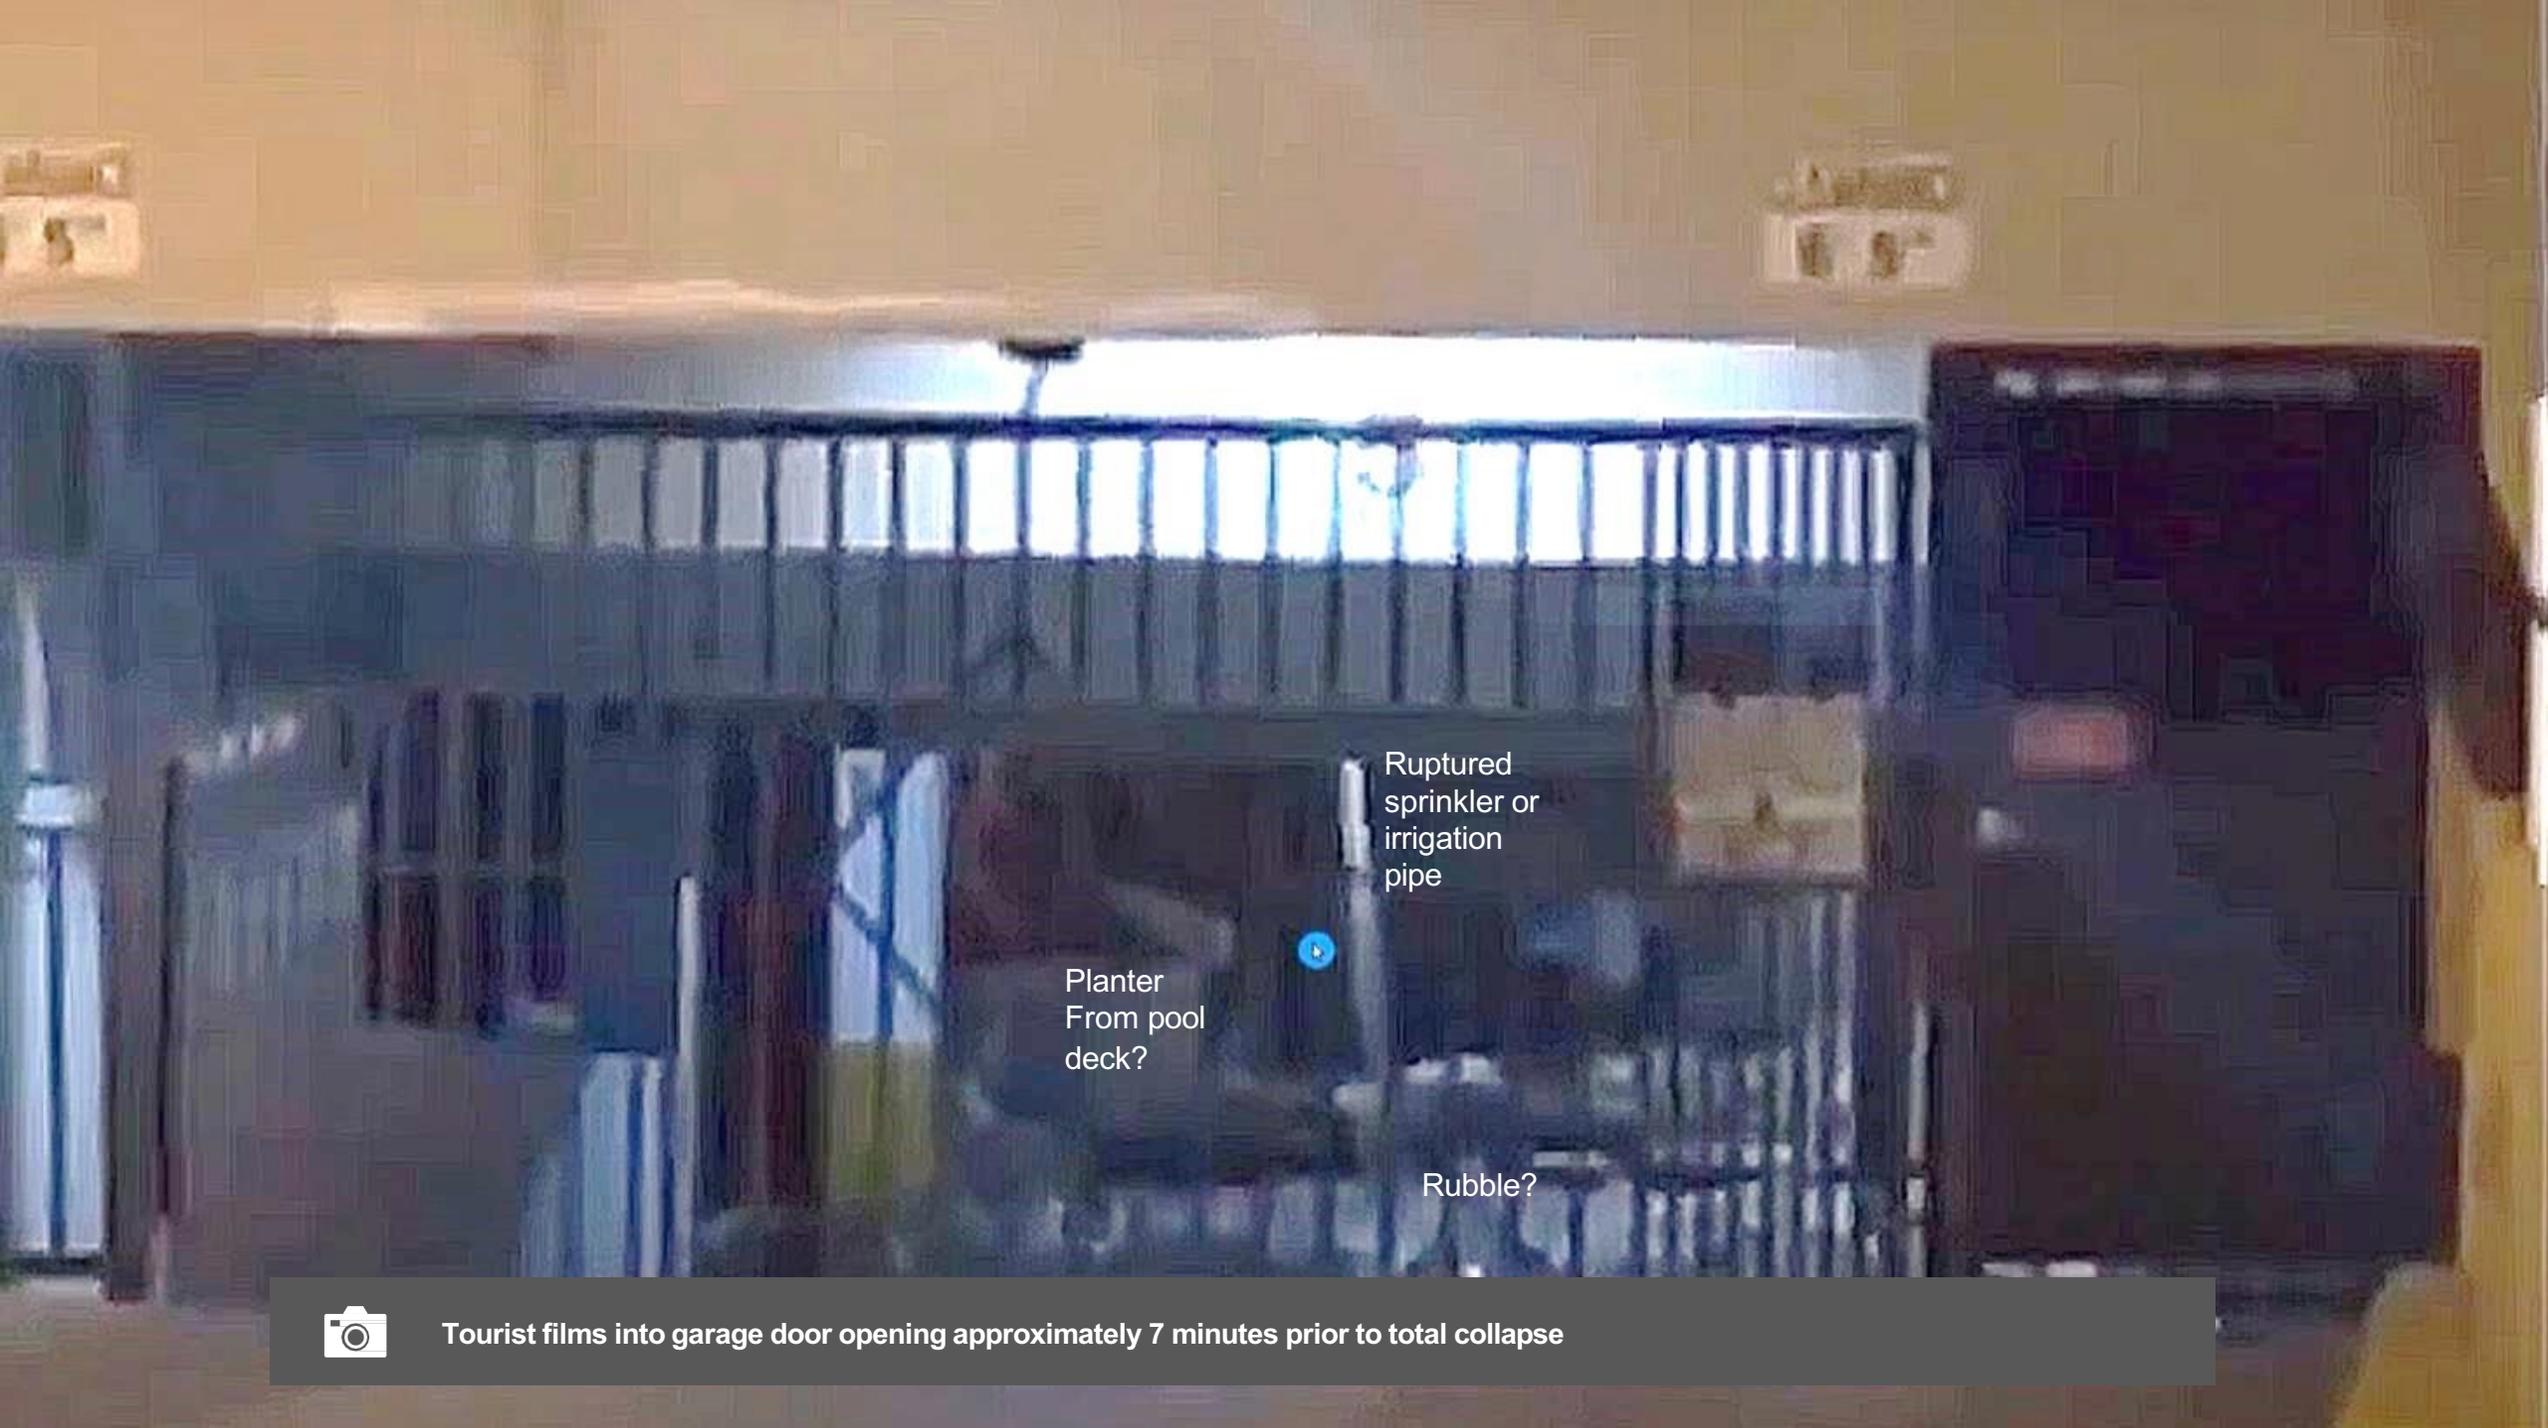
Ruptured
sprinkler or
irrigation
pipe

Planter
From pool
deck?

Rubble?

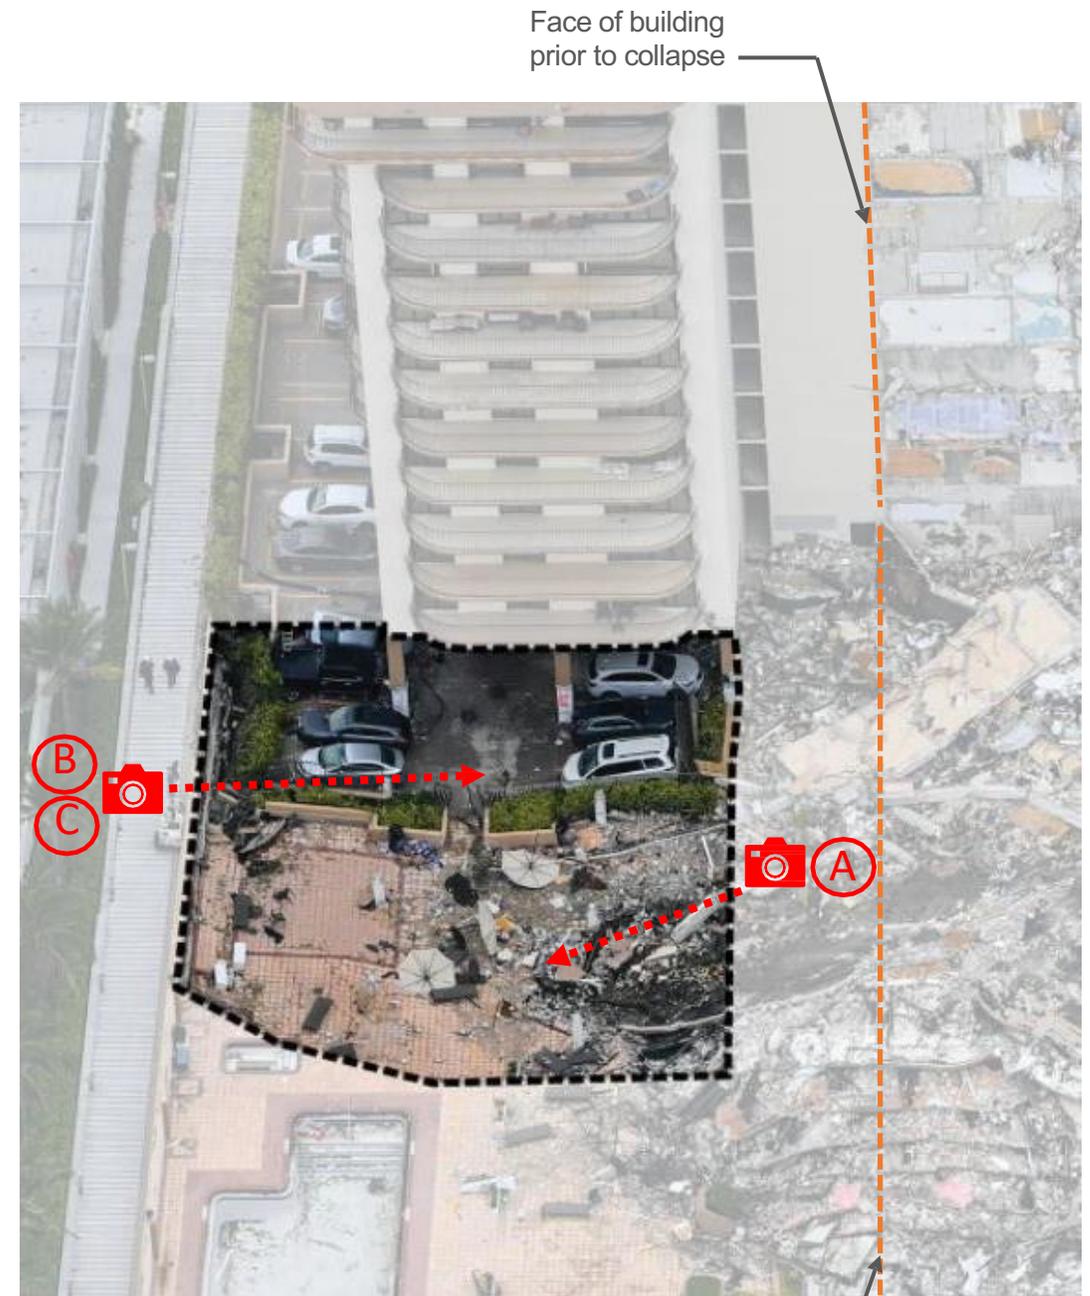
(A) Pool deck with punch through of columns down to garage
 Anomalies for NIST Forensic Investigation

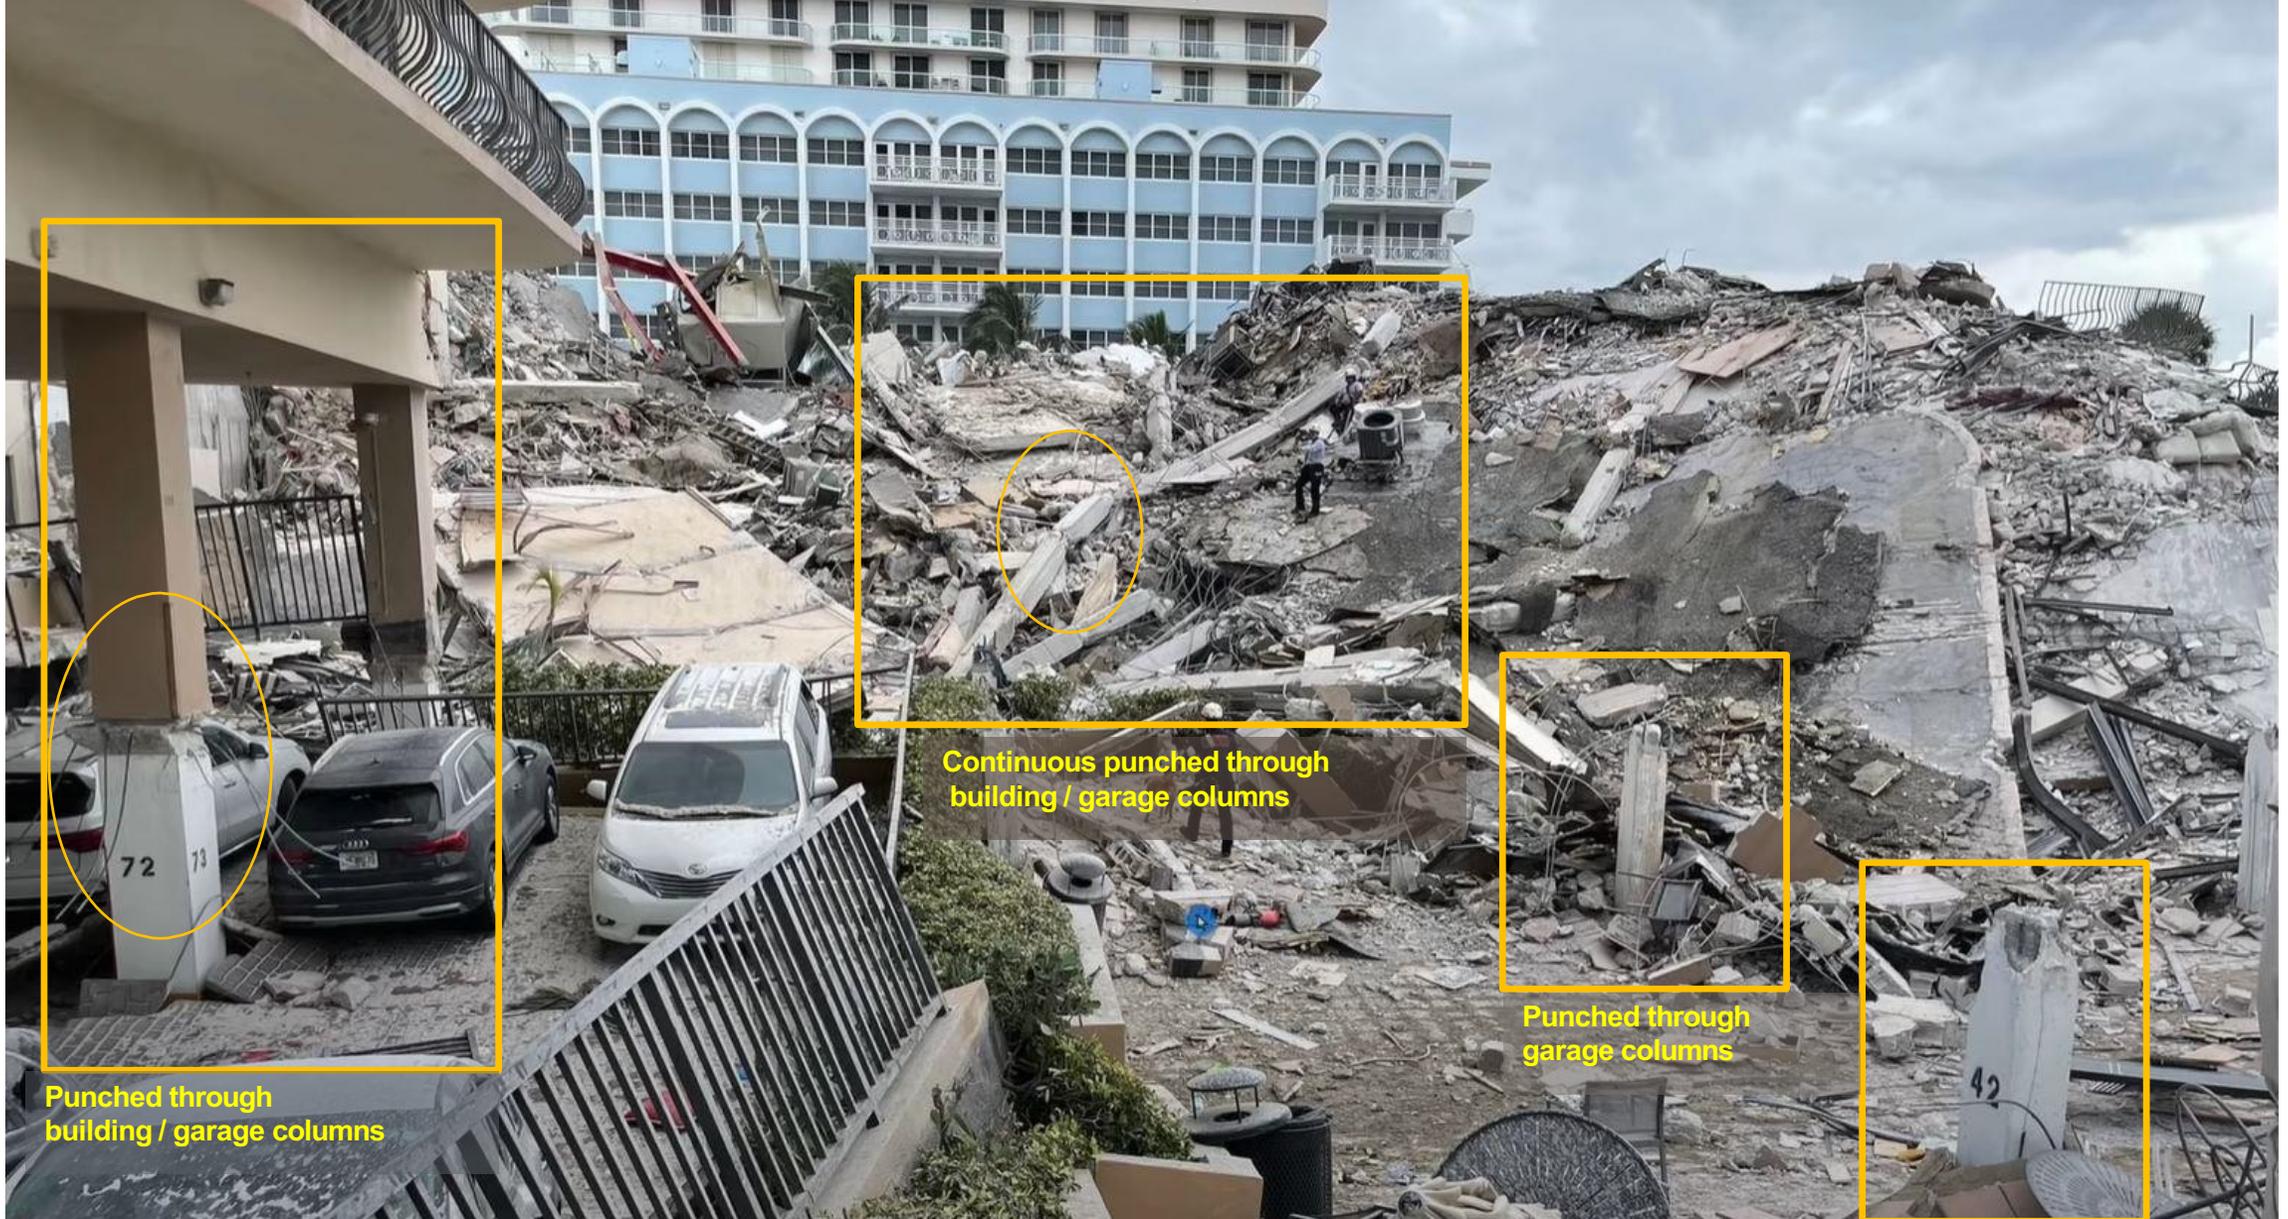
Punched through building / garage columns

Continuous punched through building / garage columns

Punched through garage columns

© Parking deck over garage, collapsed into garage below

Pool deck over garage, collapsed into garage below

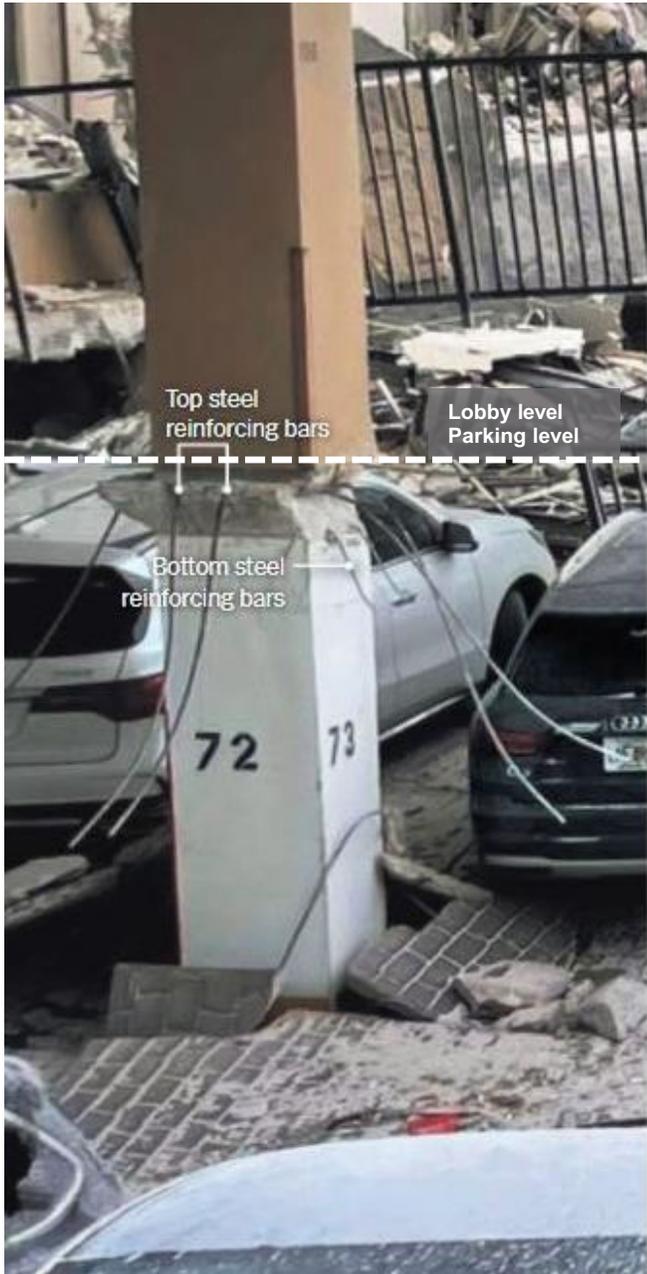
Parking deck collapsed into garage below

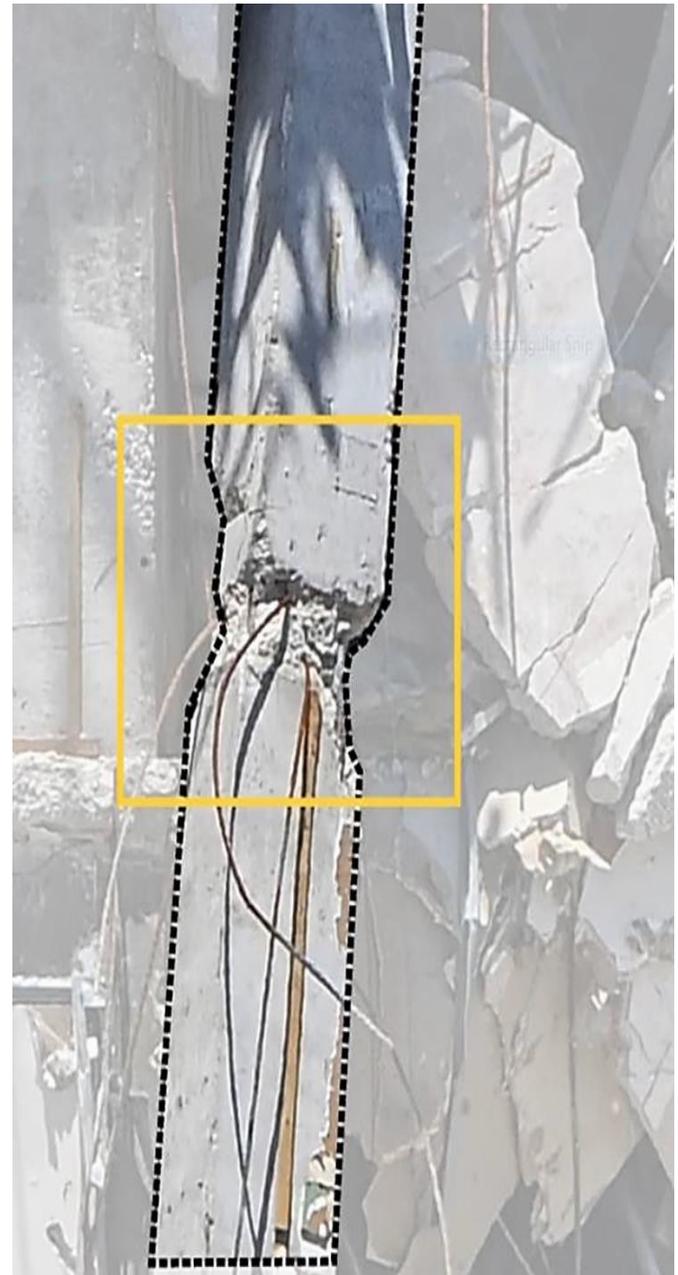
Continuous punched through building columns

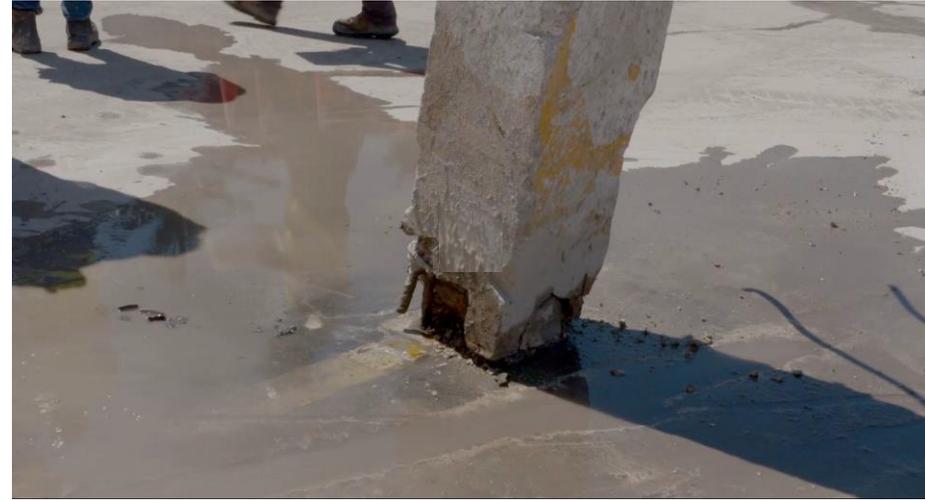
Corrosion of columns at garage slab and foundation

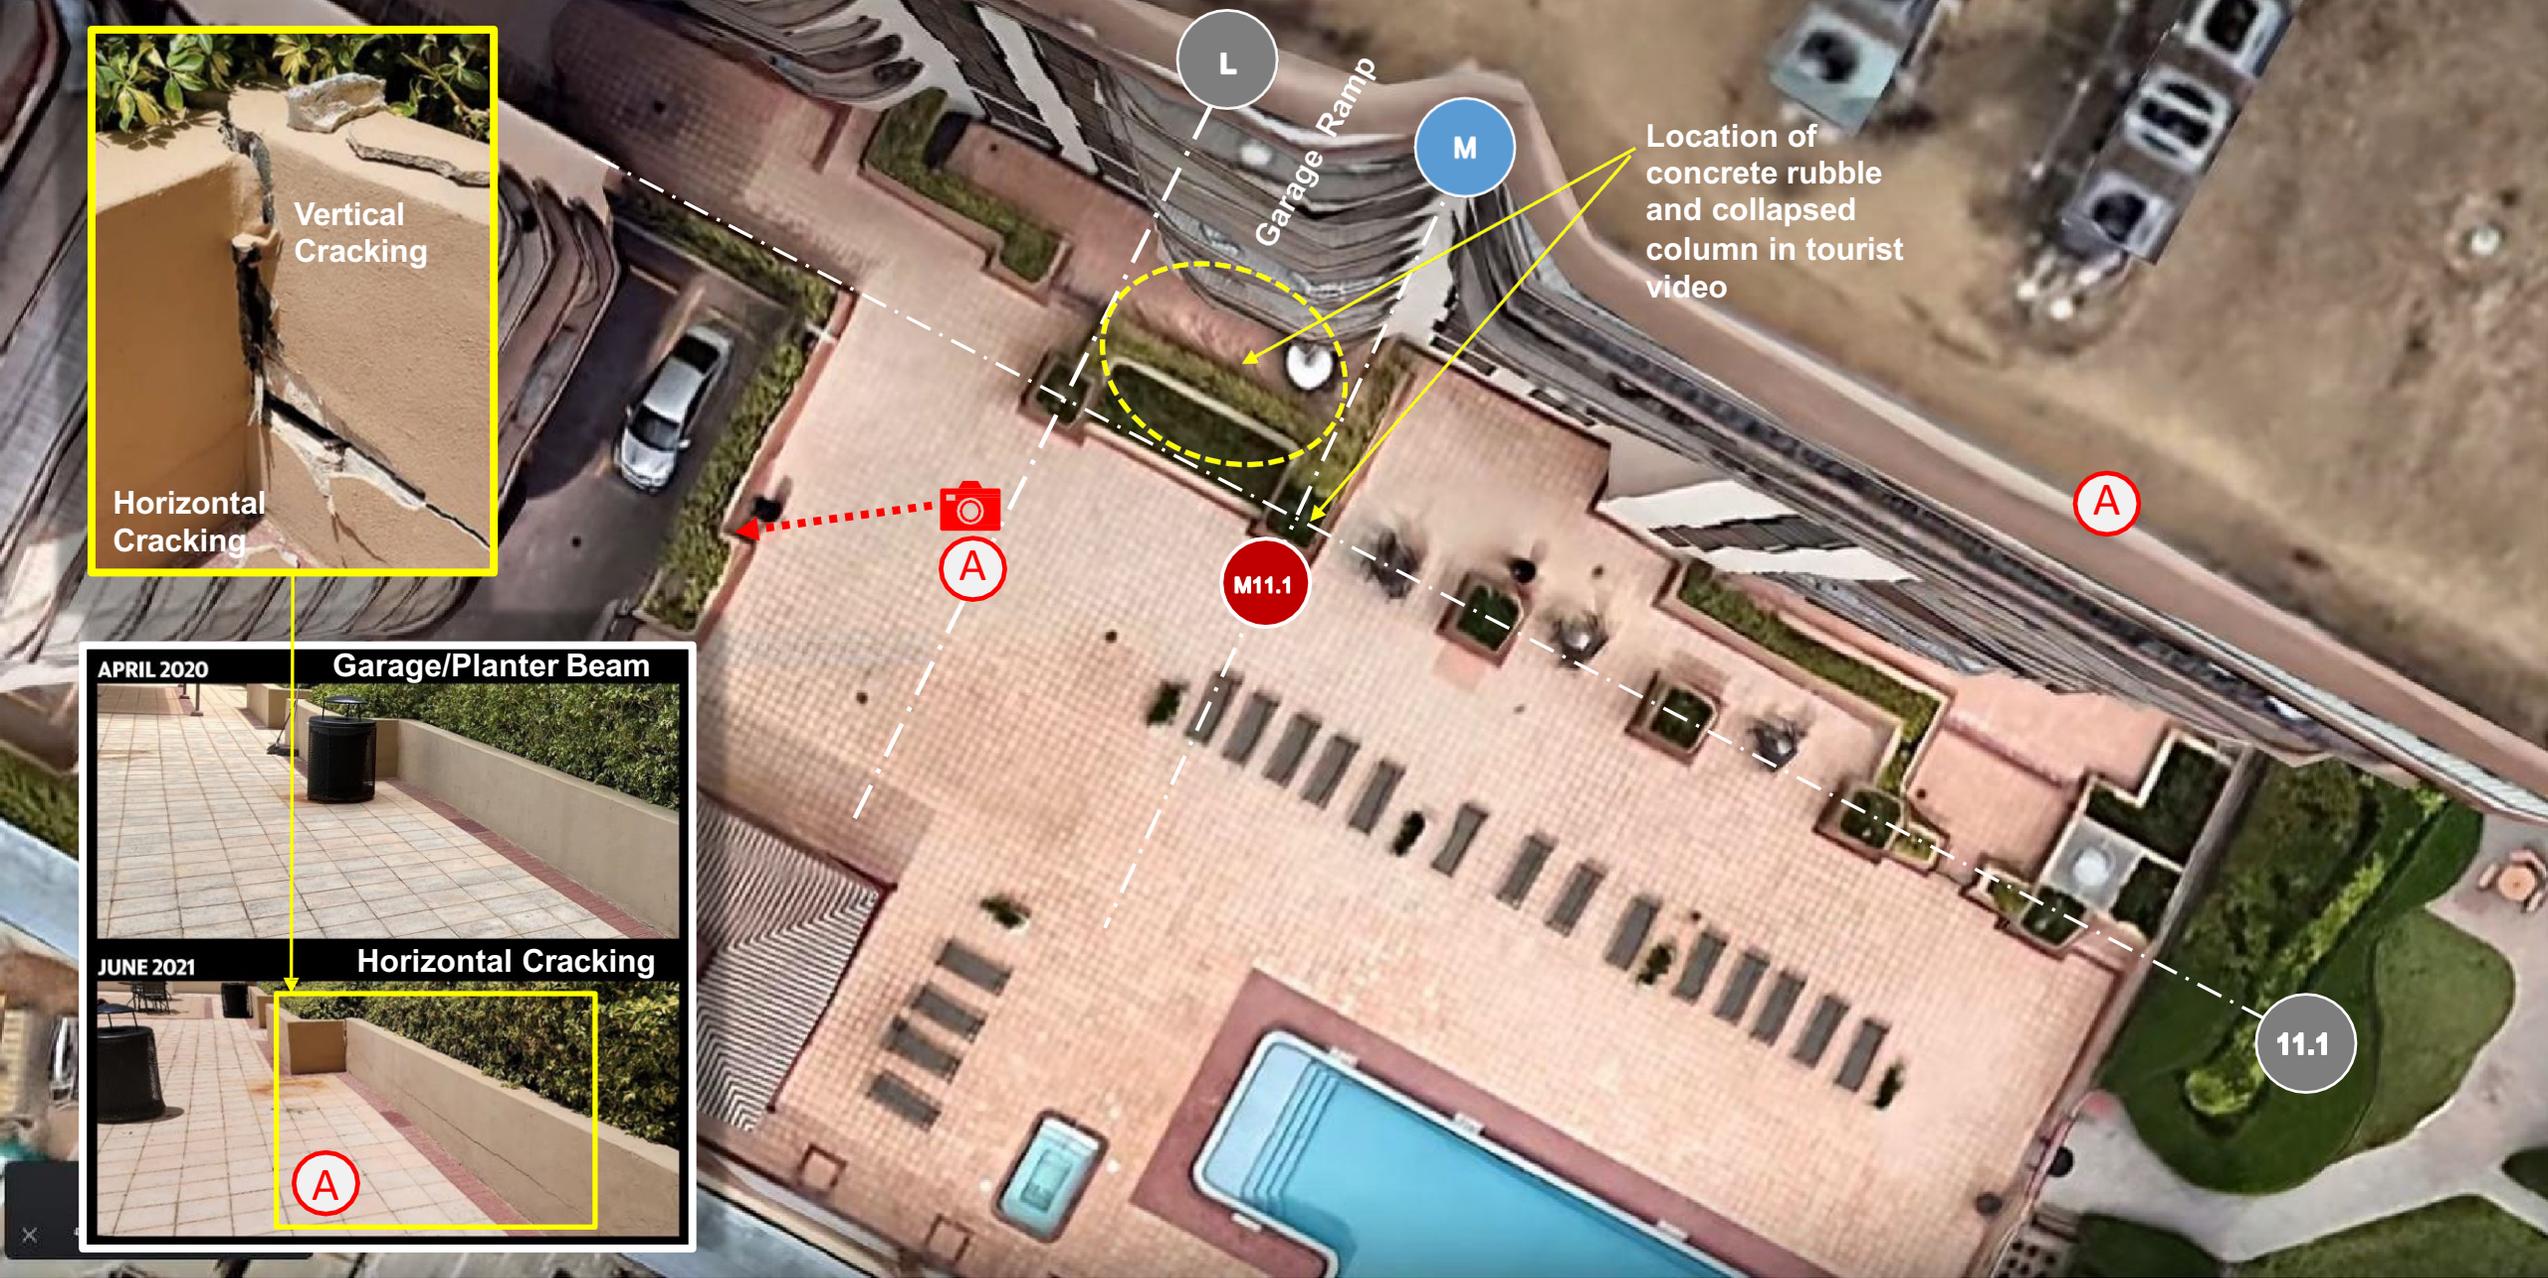
Pool deck and landscape additions from 1996 renovation. Evidence of structural displacement in 2021

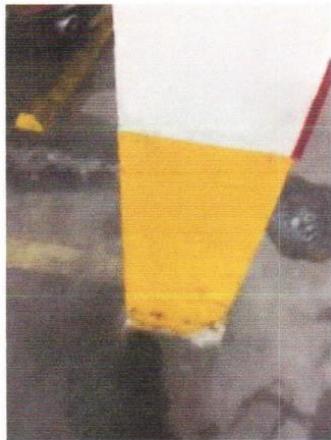
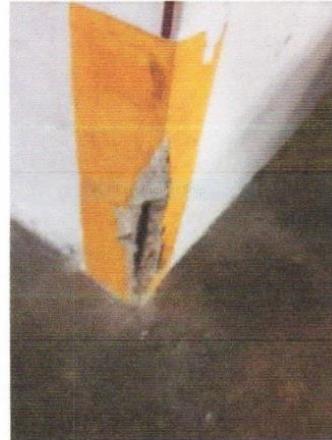
Figure J1: Typical cracking and spalling at parking garage columns

“Abundant cracking and spalling of the columns, beams and walls...sizeable spalls...underside of the pool/entrance drive/planter slabs...instances of exposed deteriorating rebar. Most is minor... concrete deterioration needs to be repaired in a timely fashion.”

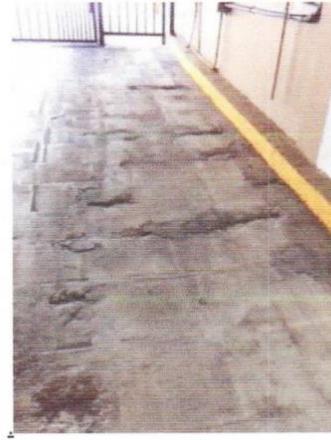
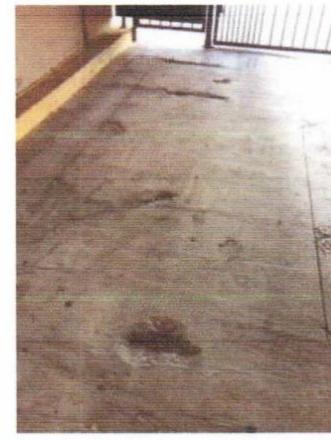
Figure J2: Spalling with exposed steel reinforcement at topside of garage deck.

“The failed waterproofing is causing major structural damage to the structural slab below these areas. Failure to replace the waterproofing in the near future will cause the extent of the concrete deterioration to expand exponentially.”

“The entrance/pool deck concrete slabs are distressed and need to be replaced in their entirety.”
