THE CHAMPLAIN TOWERS COLLAPSE

Professional & Legal Implications for Design Firms

February 22 at 2 PM ET

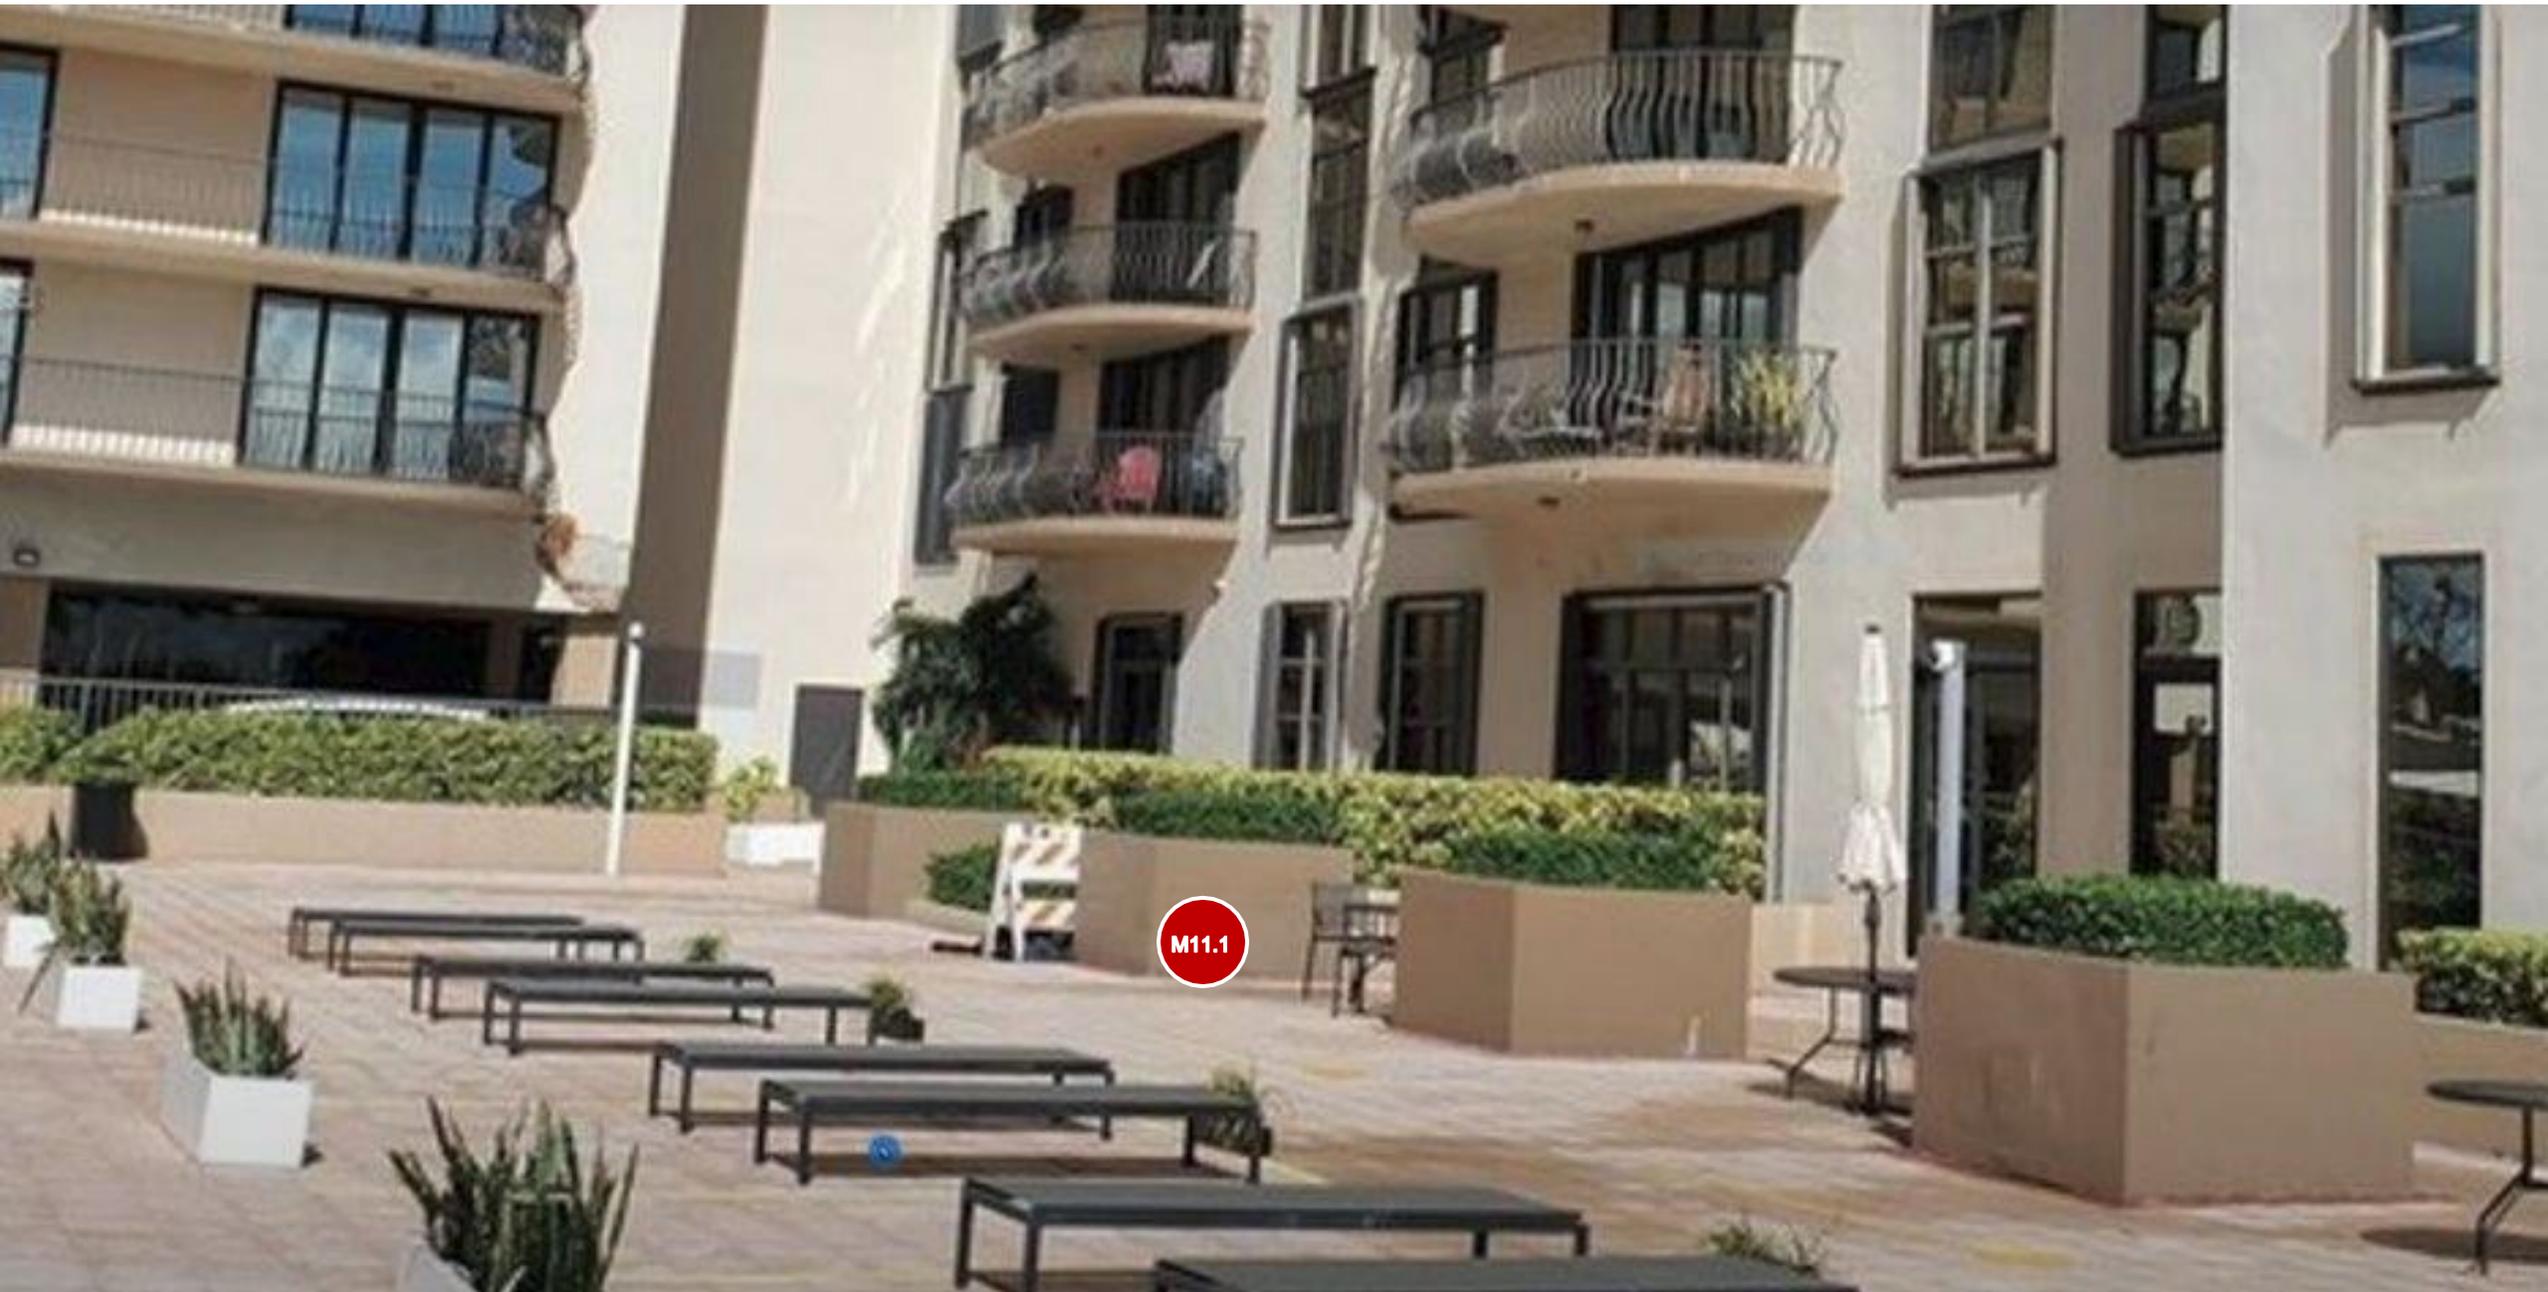
Concrete planters arranged along column line 11.1 (For several years contained palm trees)

Spalling concrete at balconies

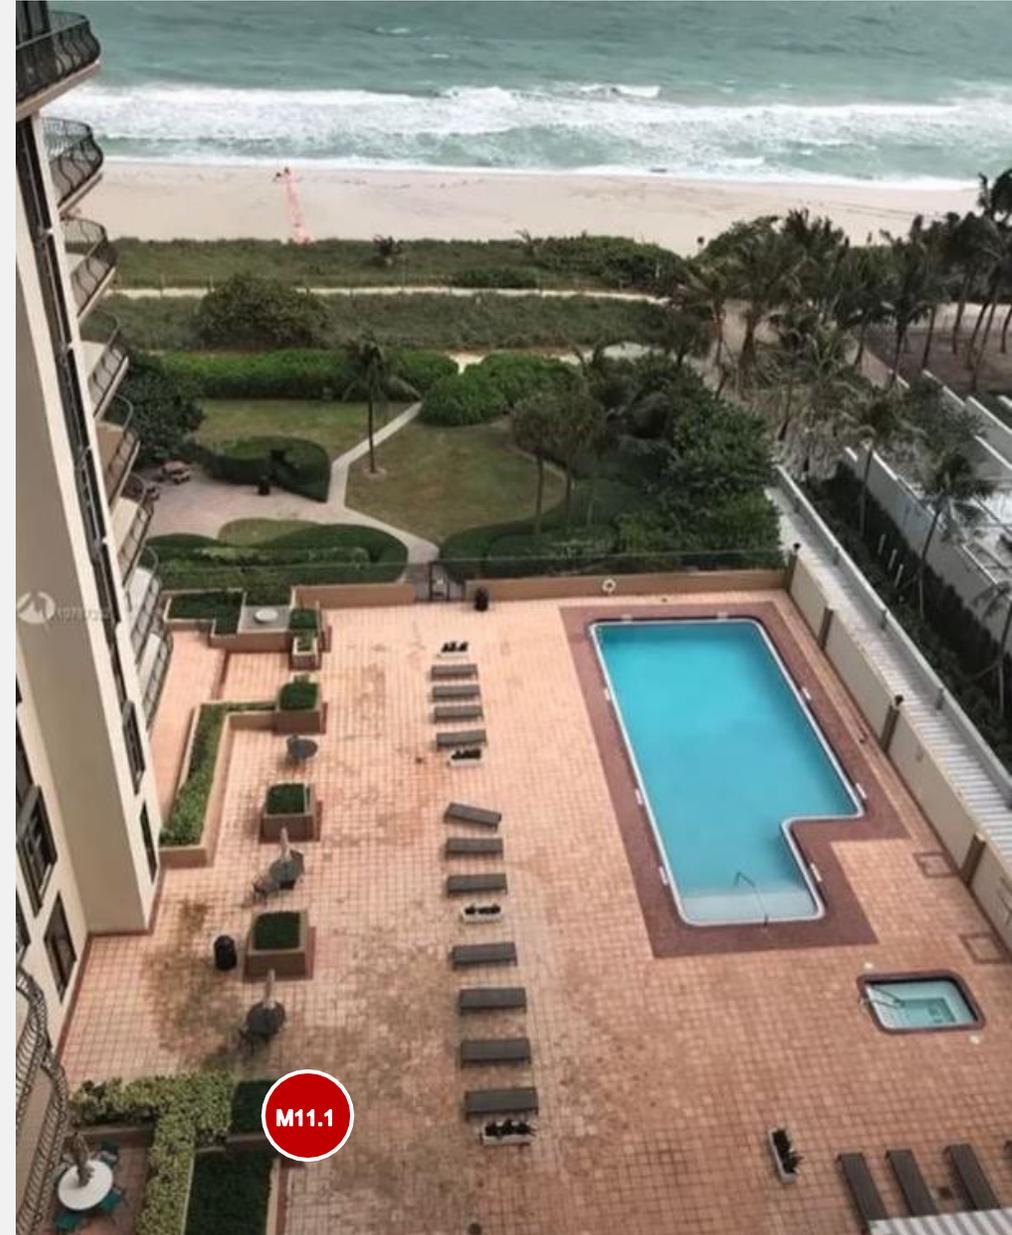
Ponding water at pool deck above garage
